Investigating Thermal Effect on a Cross Linked Polyethylene Power Cable

One of the agents responsible of the degradation of power cables in electrical distribution network is the temperature. In this paper, numerical modelling of temperature effect on the cross linked polyethylene (XLPE) insulation of a medium voltage cable containing internal defects, which are air void cavity and water tree cavities, is developed by using the finite element method and simulated by COMSOL Multiphysics Software. The experimental investigation is conducted through studying partial discharge inception voltages in XLPE insulation before and after 23 heating cycles of a 7 meters sample of a medium voltage cable at 100°C and 120°C temperatures. Partial discharge inception voltages detection were performed using the IEC60270 test method. The simulation results and experimental measurements assessed the thermal effect on the degradation of XLPE insulation.

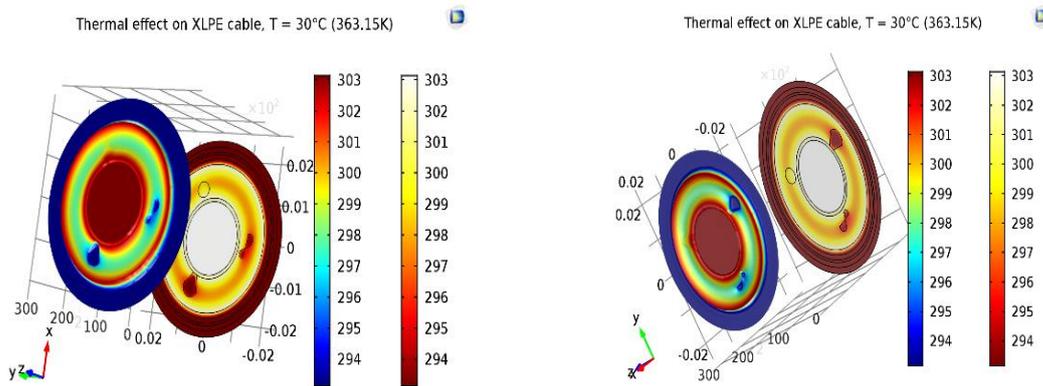
Figure 4a. Temperature Distributions in XLPE cable at Ambient Temperature: T= 30°C

The distributions of ambient temperature, normal operating temperature and maximum overload temperature are shown in Figure 4a, Figure 4b and Figure 4c respectively.

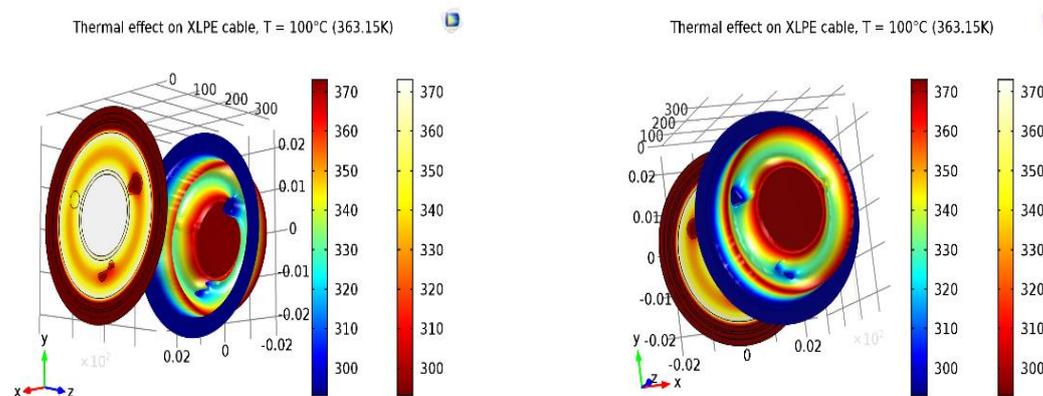
Figure 4b. Temperature Distributions in XLPE cable at Normal Operating Temperature: T= 100°C

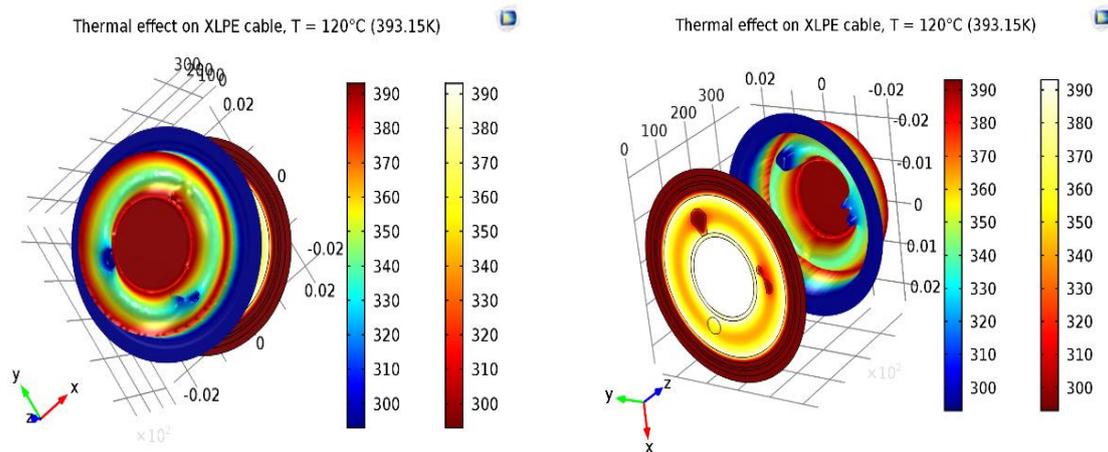
Figure 4c. Temperature distributions in XLPE cable at Maximum Overload Temperature: $T = 120^{\circ}\text{C}$

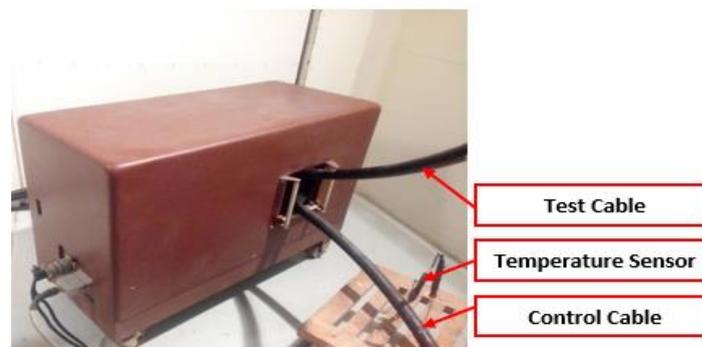
A load current transformer is used to heat the cable by applying a current of 1500 A as shown in Figure 5. Heating temperatures are chosen in accordance with IEC 60811-1-2 standard, which requires temperature $(10 \pm 2)^{\circ}\text{C}$ above the maximum conductor temperature of the cable in normal operation [12].

Figure 5. Load Current Transformer

A control cable is used to raise the temperature and allow the regulation of the current transformer, in order to ensure the good performance of heating cycle's tests.

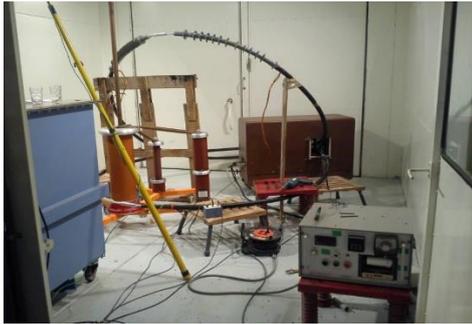
The activity of PD is continuously measured by the test circuit shown in Figure 6, [13].

Figure 6a. Partial Discharge Measurement Circuit

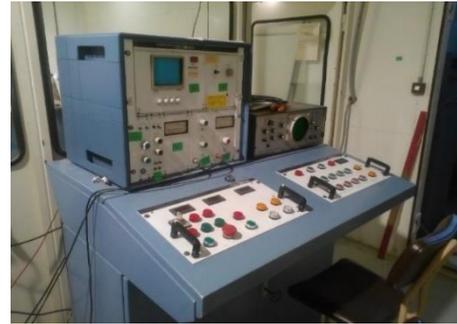
Figure 6b. Partial Discharge Detector

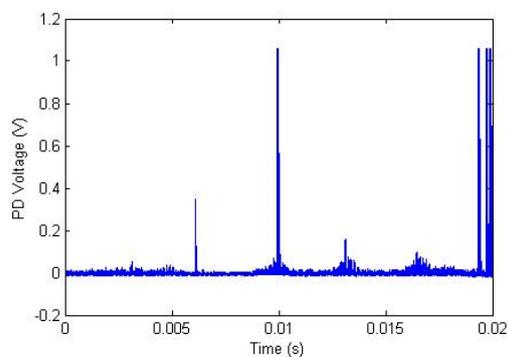
The partial discharge voltage is measured over a period of 20 ms each test day during 23 days of heating. Measurement data are recorded in the form of Excel tables, and partial discharge voltage changes over time have been represented on Matlab software. In Figure 7 is shown an example of partial discharge activities evolutions before and after the heating cycles at 120 °C for the twentieth day.

Figure 7a. Partial Discharge Activity before Heating Cycle at 120°C

PD signals have increased after heating cycles of 100°C and 120°C. Figures 4 and 5 show that PD voltage peaks passed from the range between 300mV and 400 mV to the range between 4V and 5 V by increasing the heating temperature.

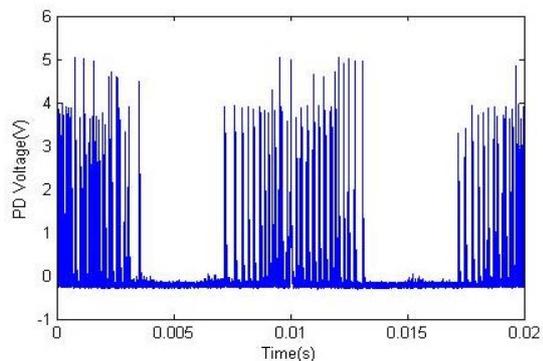
Figure 7b. Partial Discharge Activity after Heating Cycle at 120°C

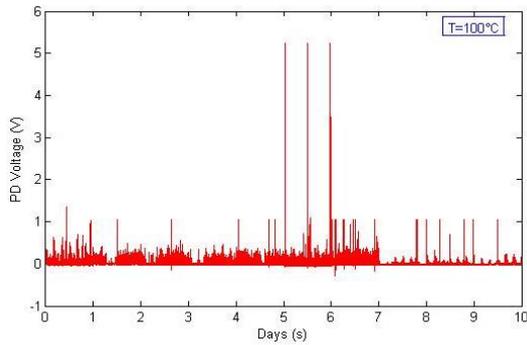
PD activity evolution during 23 heating cycles is shown in Figure 8 and Figure 9.

Figure 8a. PD voltage evolution during the heating cycles of 100°C: during the first ten days

As it can be seen, the partial discharge voltage tends to increase after heating cycles. Figure 9 shows that between days 22 and 23, the discharge pulses are characterized by very high-intensity discharge activity, and the partial discharge voltage reaches 14V whereas it did not exceed a few volts at the beginning of the heating cycle at 100 °C like is shown at Figure 8.a.

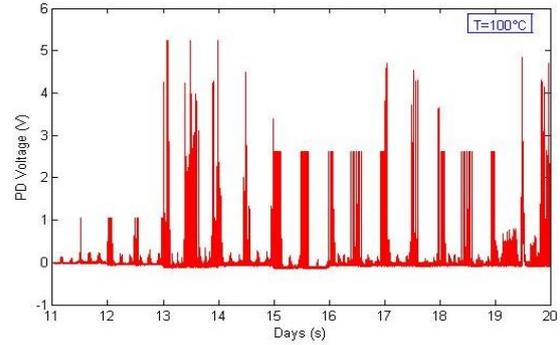
Figure 8b. Partial discharge activity after heating cycle at 120°C: during the last ten days

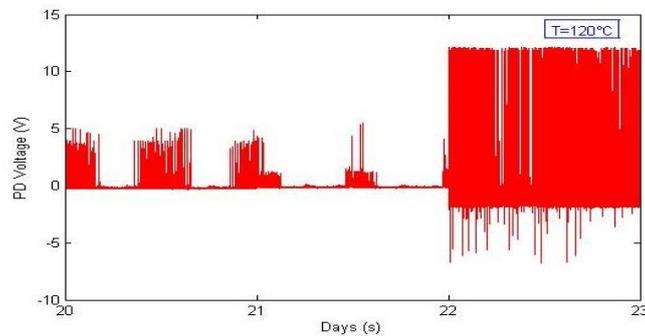
Figure 9. PD voltage evolution during the heating cycles of 120°C

This indicates the increase in surface conductivity of the cavity wall due to the erosion and chemical reactions creating dissociation products of air. This results in roughness of the surface and formation of more localized solid by-products, for example, the formation of hydrated oxalic acid crystals [15, 16].

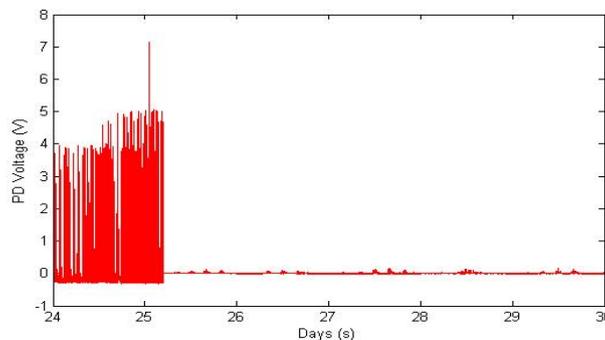
Figure 10. PD Voltage Evolution in the Sample with Artificial Cavity

Partial discharge activity continued with the artificial cavity for only six days as is shown in Figure 10 and then the cable was destroyed. PD voltage drops to almost zero for few days before the cable breakdown. According to research [18], this may take place as a result of carbonization of the partial discharges inside the void.

This phenomenon prevents the voltage build up across the void and creating a very low resistive path for very high currents flows. These high current pulses are known as 'tiny arcs'. It results in increased heating and severe insulation deterioration.

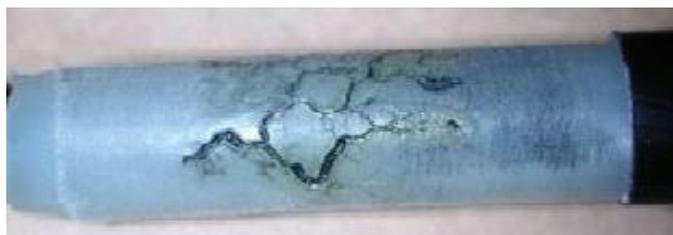
The intense heat can cause molecular and chemical breakdown of the insulation which further accelerates the deterioration process as depicted at Figure 11.

Figure 11. Damage of XLPE insulation due to accelerated ageing
