Smart monitoring system of composite plates for structural health monitoring using electromechanical impedance approach

Jayachitra Tanabalou, Rashmi Priyadarshini

Department of Electrical Electronics and Communication Engineering, Sharda University, Uttar Pradesh, India

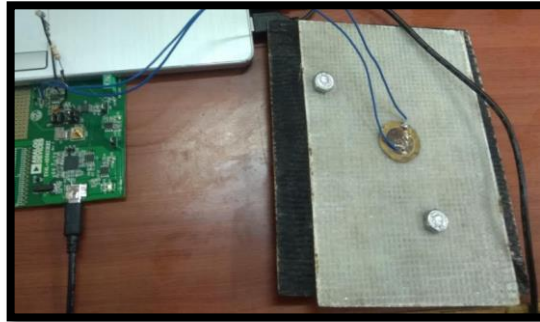
Figure 2. Impedance measurement of carbon nanotube with attached new bolt

Figure 2 specifies the interface of glass composite plate with the carbon nano tube composite plate using new bolts. The variation in the bolt position indicates the presence of damage in the structure. The bolt might get corroded in due course of time. The corroded bolts are also experimented in composite structure as shown in Figure 3. Figure 4 shows the experimentation set up of the impedance measurement in composite plates using potentiostat. The data obtained from the potentiostat was verified with the impedance measurement by AD5933.

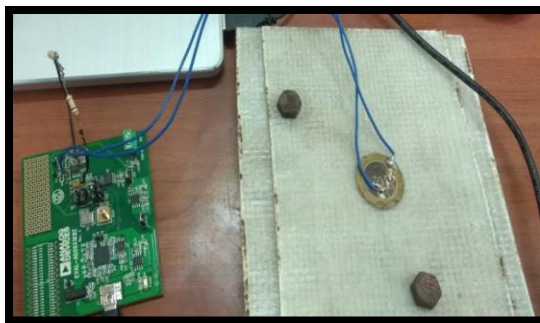
Figure 3. Impedance measurement of glass composite plate with corroded bolt

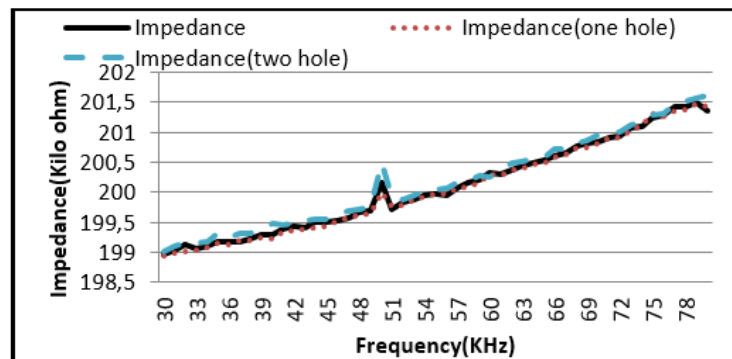
Figure 6. Impedance signature of carbon nanotube composite at different frequency with and without hole

In this proposed method, two composite plate, glass fiber and carbon nanotube were used. Damage is created artificially in this experiment by drilling a hole in the composite plates. Impedance signatures were measured with undamaged and damaged position. Figures 5 and 6 show the impedance signatures obtained between undamaged and two different types of damage in glass fiber composite and carbon nanotube composite plate. The inclusions of two holes using driller are the damages introduced in the composite structures. The impedance increases clearly when subjected to damage. The impedance peak was high at 50 KHz which is resonant frequency. The resonant frequency of the undamaged system is the same as the damaged system but the amplitude varies. The impedance value increases as the damage level in the composite plate increases. The impedance increases from 199.7 K Ω to 200.5 K Ω which shows the presence of damage on the structure.

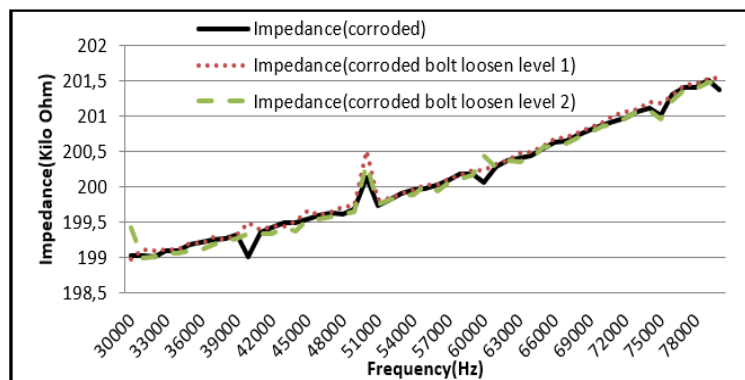
Figure 9. Impedance signature of glass fiber composite at different frequency with loosening of corroded bolt

Due to varying environment conditions, there are high chances of corrosion to occur in bolts so the experiment was extended by using corroded bolts. Figures 9 and 10 show the impedance signatures of using

corroded bolts in composite glass fiber and carbon nanotube composite. The impedance value increases as the bolts are interchanged with the corroded bolts. The impedance peak occurs at 40 KHz and 50 KHz.

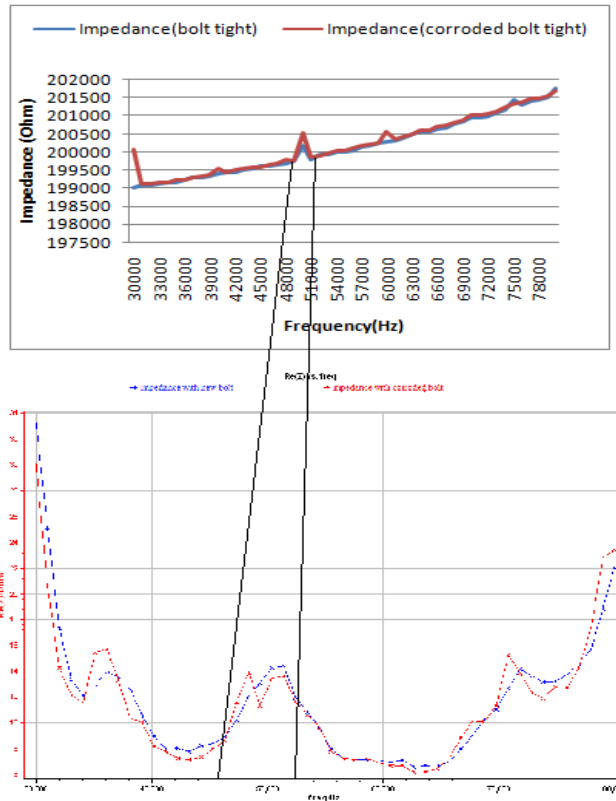
Figure 11. Comparison of Impedance signature from AD5933 and potentiostat at different frequency of glass fiber composite plate

The same experimental set up was used for verification by potentiostat. From the Figures 11 and 12 the impedance peak remains the same in potentiostat and impedance chip which occurs at 50 KHz. The amplitude of impedance increases as the damage level increases. The multiple peaks of impedance signatures at different frequency level have a good agreement with the conventional impedance measurement.

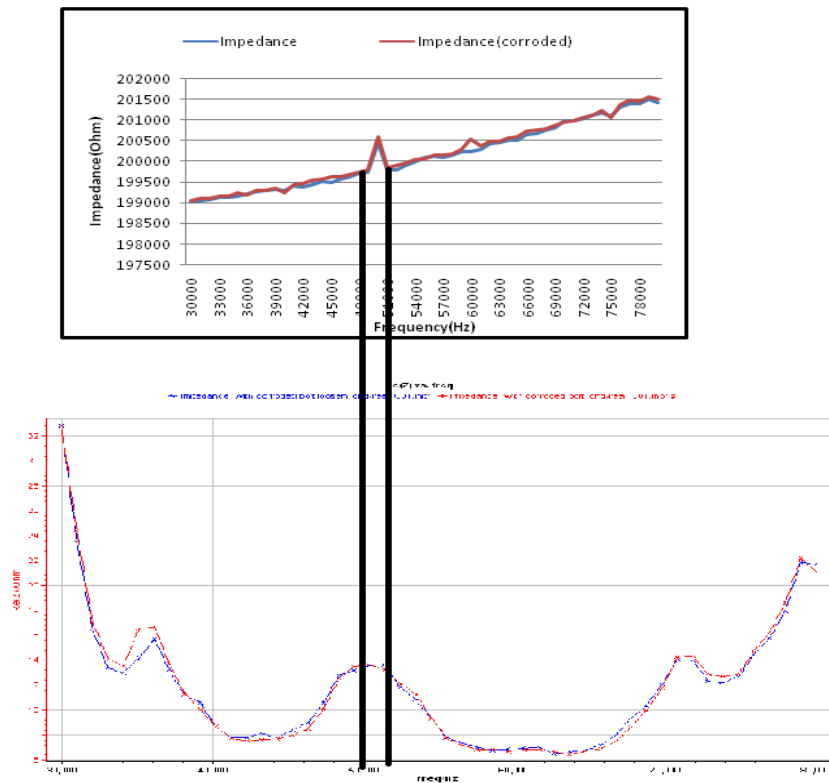
Figure 12. Comparison of Impedance signature from AD5933 and potentiostat at different frequency of carbon nano tube composite plate
