Aging Detection of Glass Disc Insulator by Using **Infrared Camera**

Mohammed Imran Mousa*¹, Zulkurnain Abdul-Malek², Zainab I. M.³
^{1,2}Institute of High Voltage and High Current, Faculty of Electrical Engineering, Universiti Teknologi Malaysia, Johor Bahru, Malaysia ³Babil Division, Ministry of Higher Education and Scientific Research, Babil, Iraq *Corresponding author, e-mail: mohammedimran745@yahoo.com

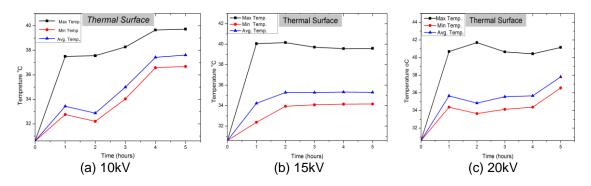
Figure 3. Thermal profile over five-hour period of the insulator surface for sample D, (a) 10 kV, (b) 15kV, and (c) 20kV

Figure 3 shows the maximum temperature of the glass insulator surface, and it is seen to drastically increase with time duringthe first hour. The average and minimum temperature behaviors follow the same trend. The average and minimum temperature increments from an ambient temperature through the first hour are shown in Figures 3 (b) and (c).

The surface of the glass insulator heated up due to the applied high voltage across the insulator. After a certain time, it reached the steady-state condition. The larger the applied voltage, the larger would be the steady state temperature. In addition, the average and minimum temperatures, which are also plotted on the same respective graphs, were affected by the level and distribution of the maximum temperatures (appeared as hot spots when using infrared camera).

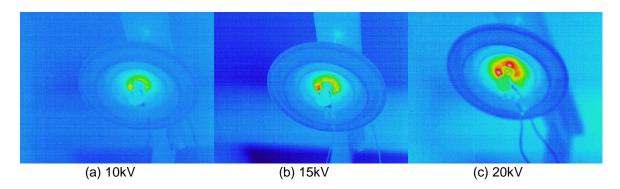
Figure 7. The thermal images of sample B for various applied voltages; (a)10kV, (b) 15 kV, and (c) 20 kV

Figure 7 shows the thermal images representing the surface temperatures distributed over the surface of the insulator for various applied voltages (10kV, 15 kV and 20 kV) for sample C. The infrared camera shows higher temperatures were concentrated around the pin and gradually spreading and decreasing toward outer diameter of the glass insulator. The glass insulator surface was seen to have a hot spot. The hot spot becomes more intensed with the applied voltage. Figure 8 shows the histogram of the temperatures distribution on the surface of the insulator, for applied voltage of 10kV, 15 kV and 20 kV on sample B. The histogram analysed the thermal images by grouping the image pixels according to their temperature. The histogram is another way to show the temperature distribution of the glass surface. A higher applied voltage led to raised minimum limit of the surface temperatures, and hence the range of temperatures across the glass insulator became wider.

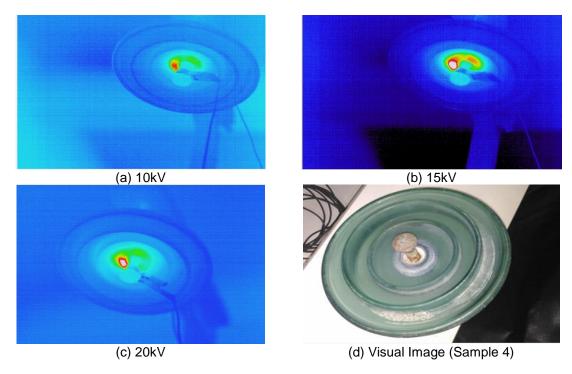
Figure 9. Thermal images of sample A after 5 hours, when applied with various voltages; (a) 10kV, (b) 15kV, and (c) 20 kV; and (d) Visual image of the insulator

Figure 9 shows thermal images for sample A after five hours, when various voltages were applied. The invisible damage can be indicated in the thermal image as a hot spot, where it can be seen that the hot spot brightness increases with the applied voltage.
